## **ASBESTOS SURVEY**

Westlink Library 8515 W. Bekemeyer Wichita, Kansas

October 5, 2023

RE: Asbestos survey – Westlink Library, 8515 W. Bekemeyer, Wichita, KS.

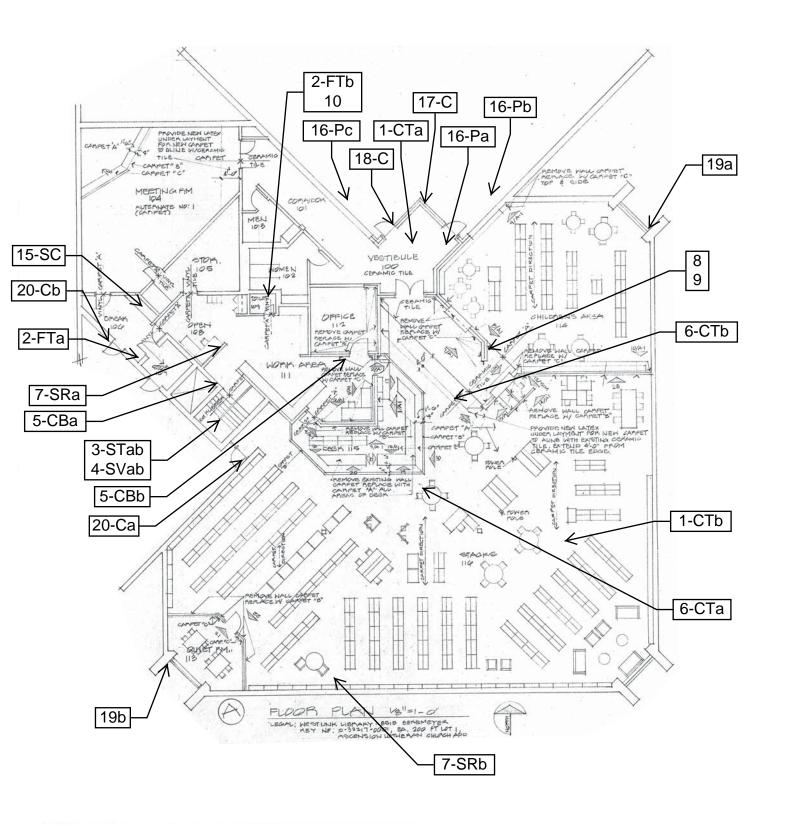
## SAMPLE LOCATION MAP

Project Westlink Library - Basement	Date 21-Sep-23
Location Wichita, KS	By D. Helsel
Client City of Wichita	Job No.

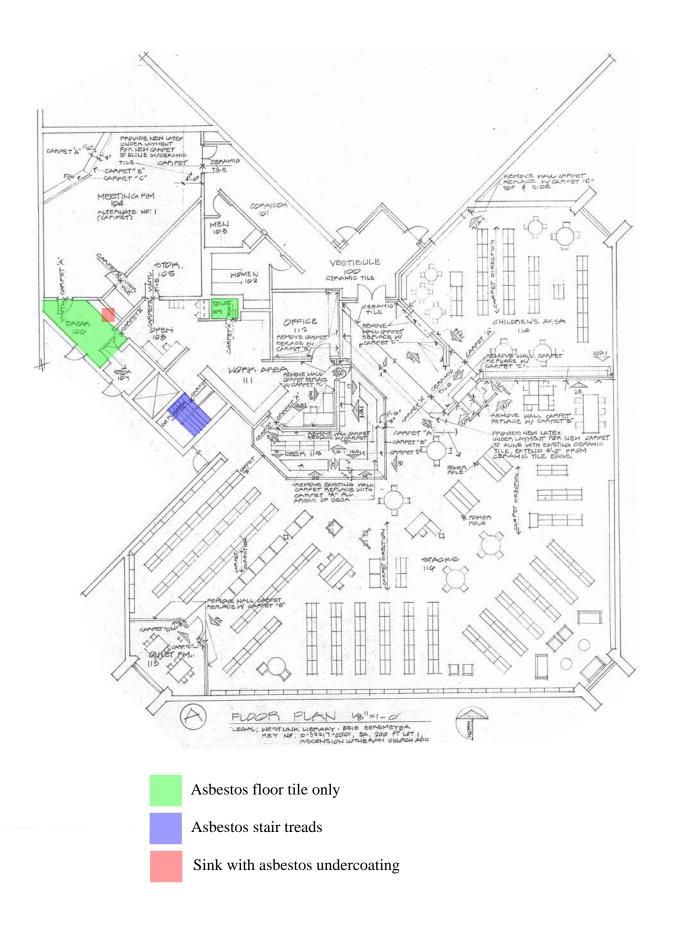
# ASBESTOS LOCATION MAP

- Approximately 162 sf of asbestos floor tile only. See location map for location of material.
- Approximately 80 sf of blue asbestos stair tread. See location map for location of material.

• Approximately 1 sink with asbestos undercoating. See location map for location of material

Note: The above category I non-friable asbestos containing materials <u>do not</u> need to be removed prior to demolition or renovation activities unless applied to concrete that will be recycled or if it will be subject to crushing, crumbling, pulverizing or otherwise rendered friable.

Note: The above category II non-friable asbestos containing materials must be removed prior to demolition or renovation if it will be subjected to crushing, crumbling, pulverizing or otherwise rendered friable by demolition or renovation activities.
